PERFORMANCE OF INCONEL 550 TURBINE BLADES
IN A TURBOJET ENGINE AND EFFECTS OF
DIFFERENT FORGING TEMPERATURES
AND HEAT TREATMENTS

By C. A. Gyorgak, J. R. Johnston, and J. W. Weeton

Lewis Flight Propulsion Laboratory
CLASSIFICATION CHANGED Cleveland, Ohio

August 16, 1955

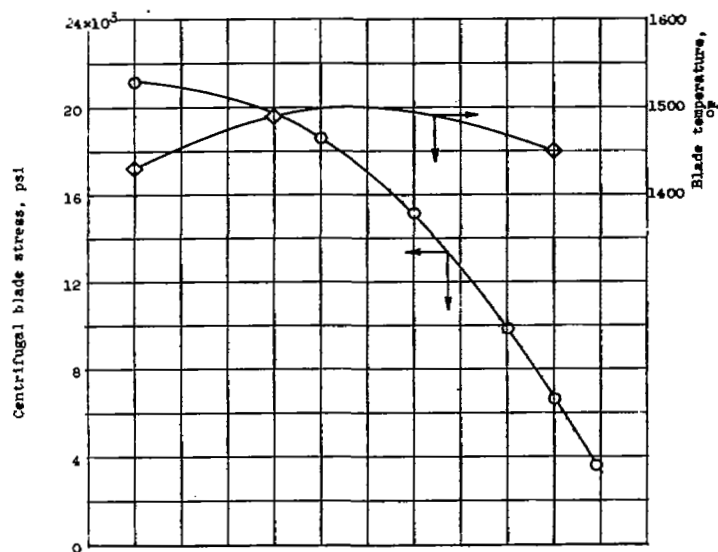
(a) Stress and temperature distribution.

Figure 1. - Stress and temperature distribution in Inconel 550 turbine blade at rated speed and corresponding stress-rupture life of specimens cut from airfoils of group 1 blades.

Stress and temperature distribution in turbine blades during engine operation. - The cross sections of two as-received Inconel 550 blades were measured with an optical comparator to permit calculation of the centrifugal-stress distribution along the blade length (ref. 3).

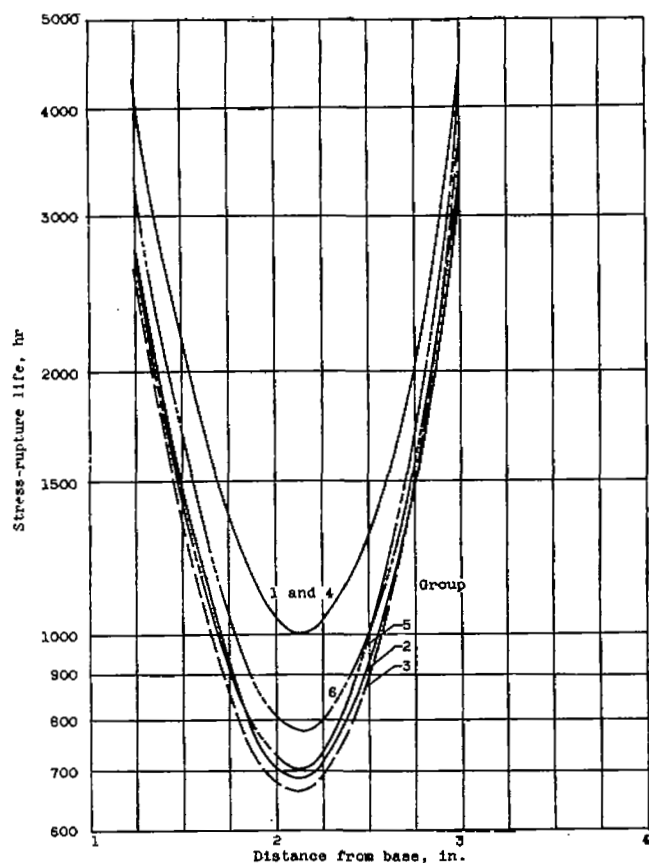
(b) Stress-rupture life.

The stress-rupture life of the alloy corresponding to the conditions of centrifugal stress and temperature at different sections of the airfoil is also shown in figure 1. These curves were constructed using data for blade airfoil specimens (table II) and manufacturer's data. Several different extrapolation procedures were used. The results obtained for the minimum stress-rupture life were very similar because this extrapolation was limited to small differences in stress and temperature. If the failures result solely from the most severe combination of stress and temperature, blades would be expected to fail in a "critical zone" with operating lives approximately equal to the minimums of the stress-rupture-life curves.

(1) A comparison of the life of the blades in the engine with the predicted life based on stress-rupture considerations only (fig. 1(b)). Factors other than stress-rupture (e.g., vibratory stress and thermal shock) generally would tend to reduce the life below that predicted.

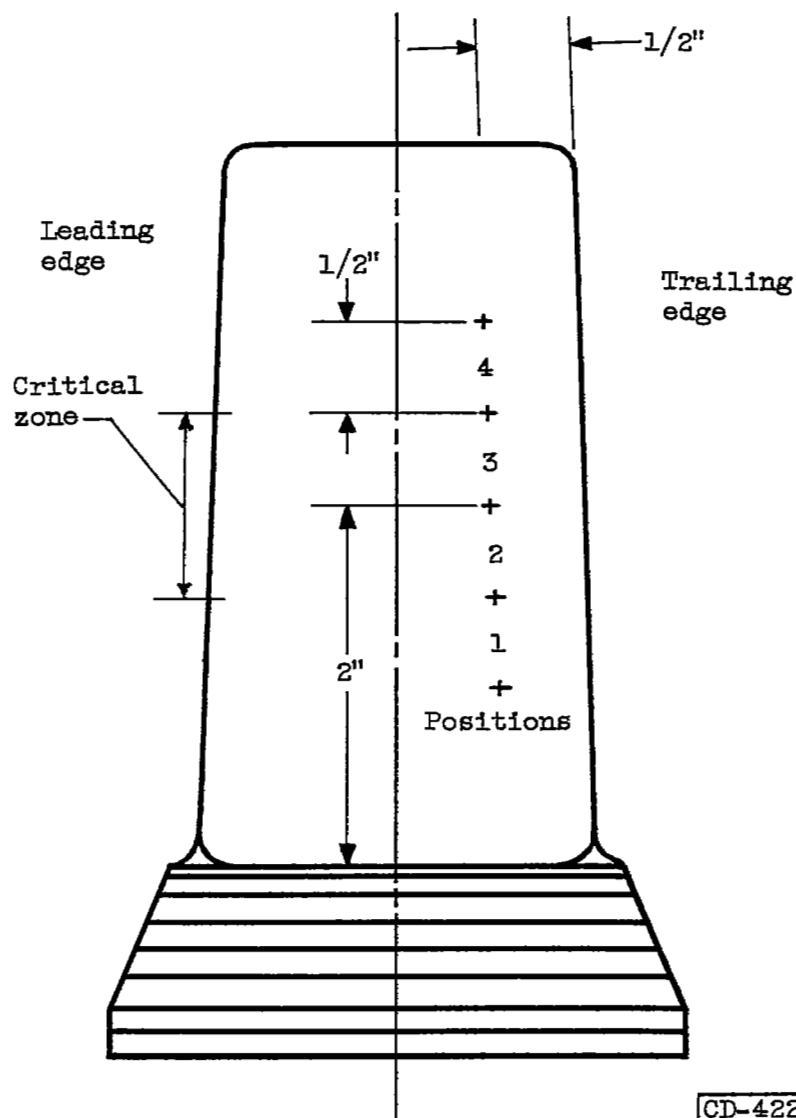
Figure 2. - Location of scribe marks on convex side of turbine blade for use in measuring elongation.

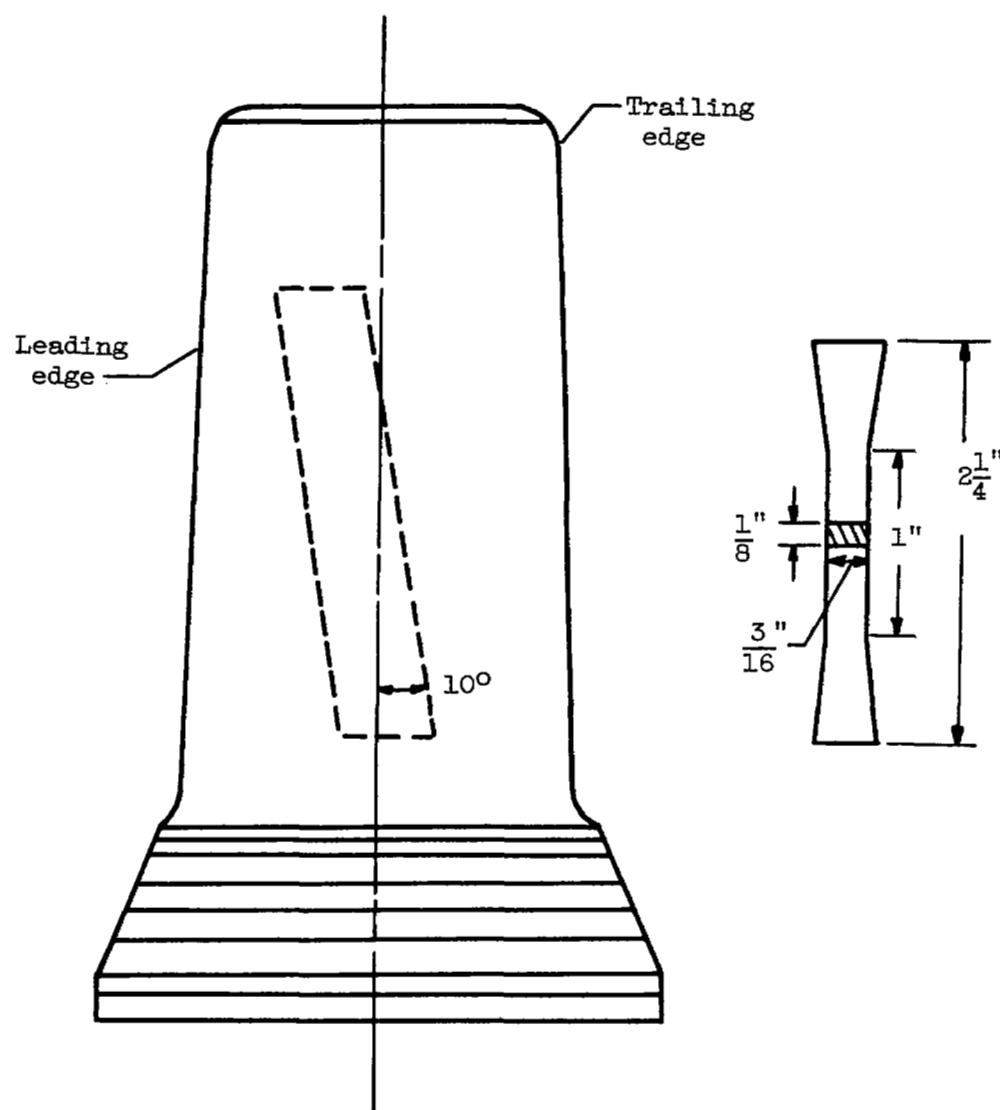
Figure 3. - Blade stress-rupture specimen and zone from which it was machined.

Stress-rupture specimens were machined from the airfoil as shown in figure 3. Specimens of each group were tested at stress levels of 20,000, 25,000, and 30,000 psi at 1500° F.

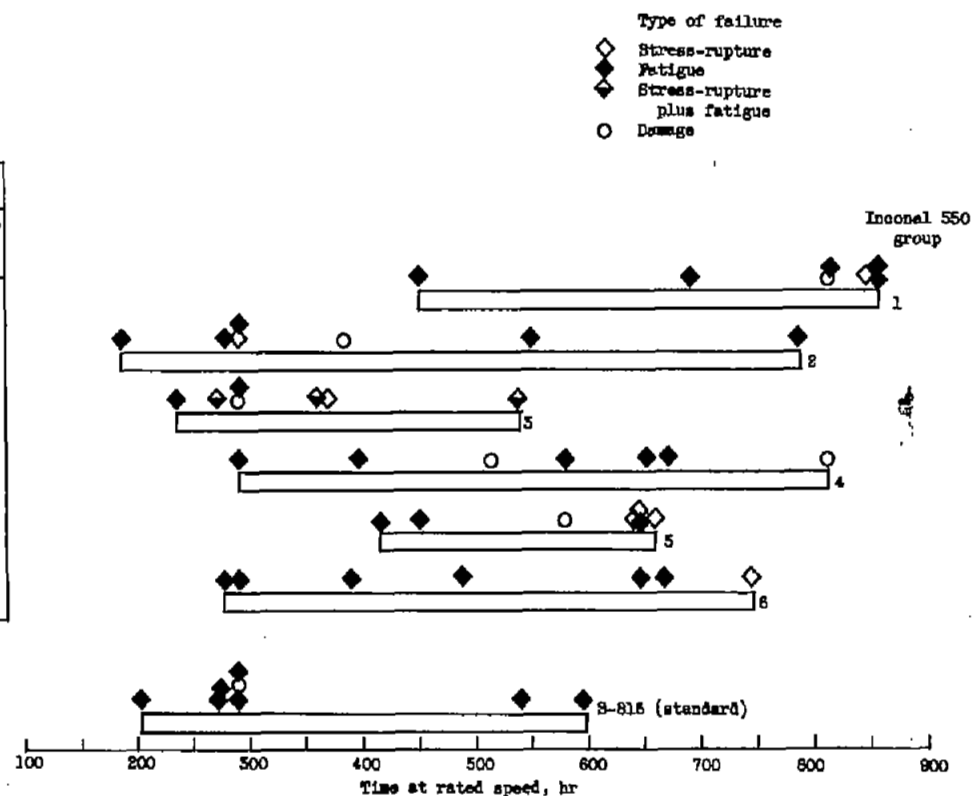
Figure 4. - Effect of forging temperature and heat treatment on blade life of Inconel 550 in turbojet engine.

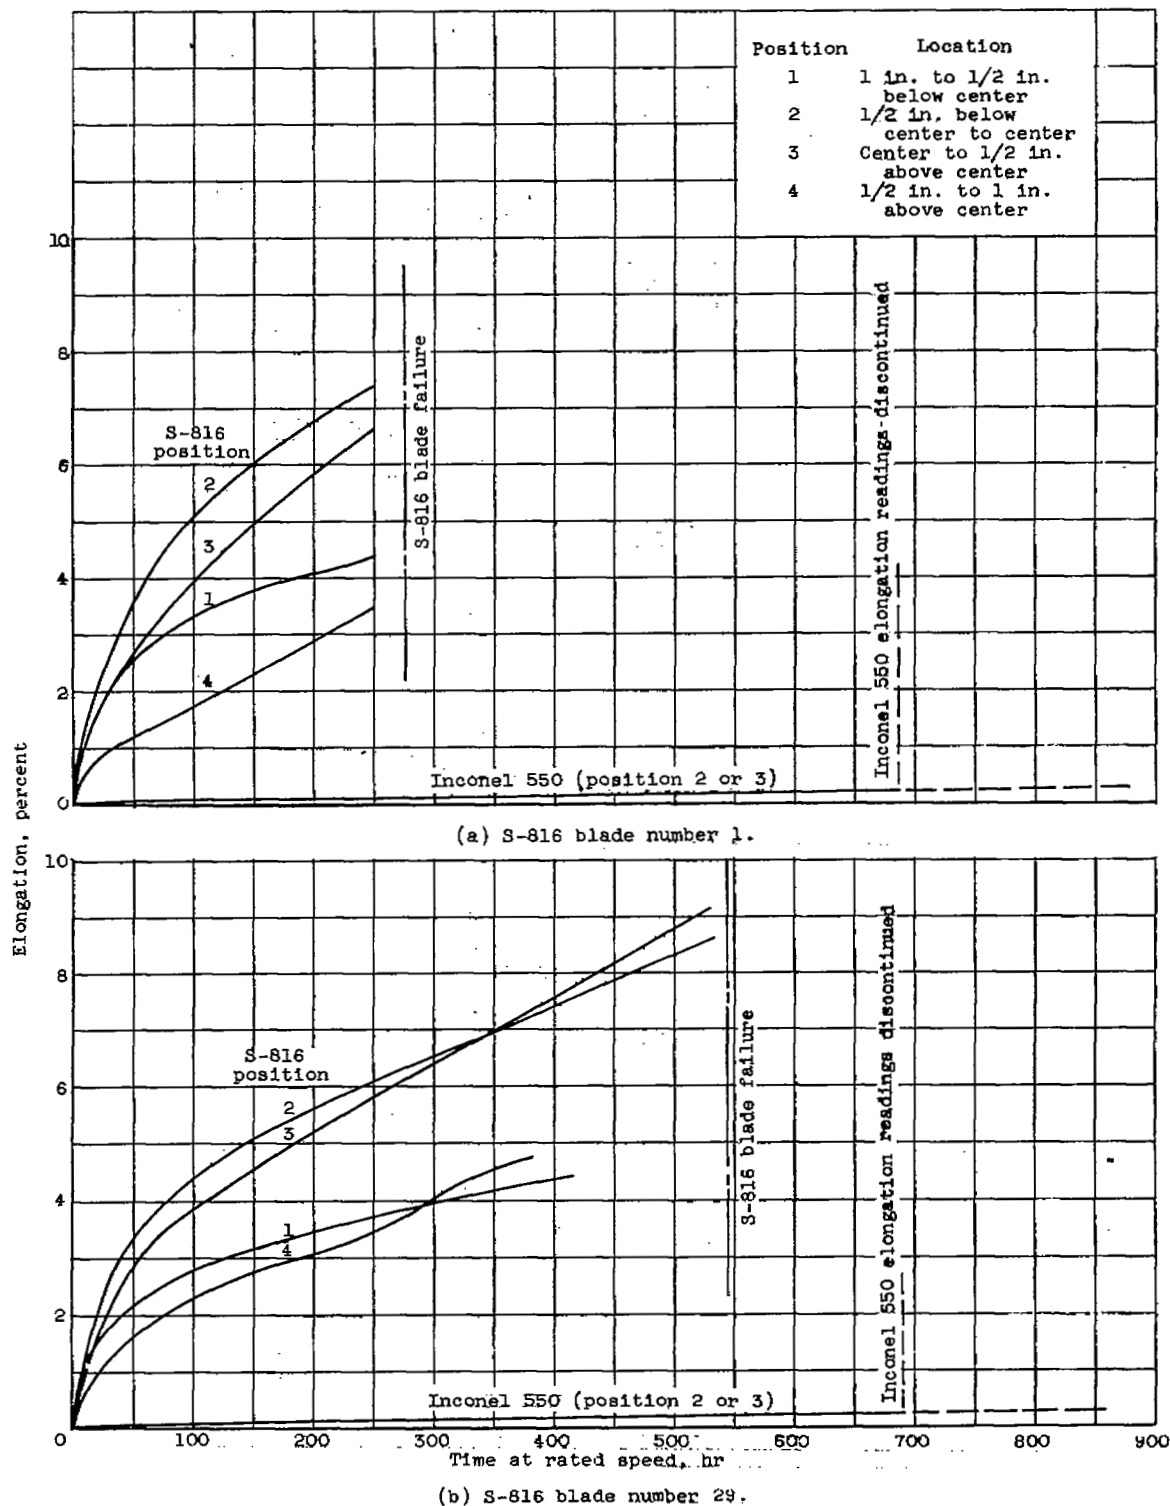
Figure 5. - Maximum elongation of Inconel 550 compared with elongation of S-816.

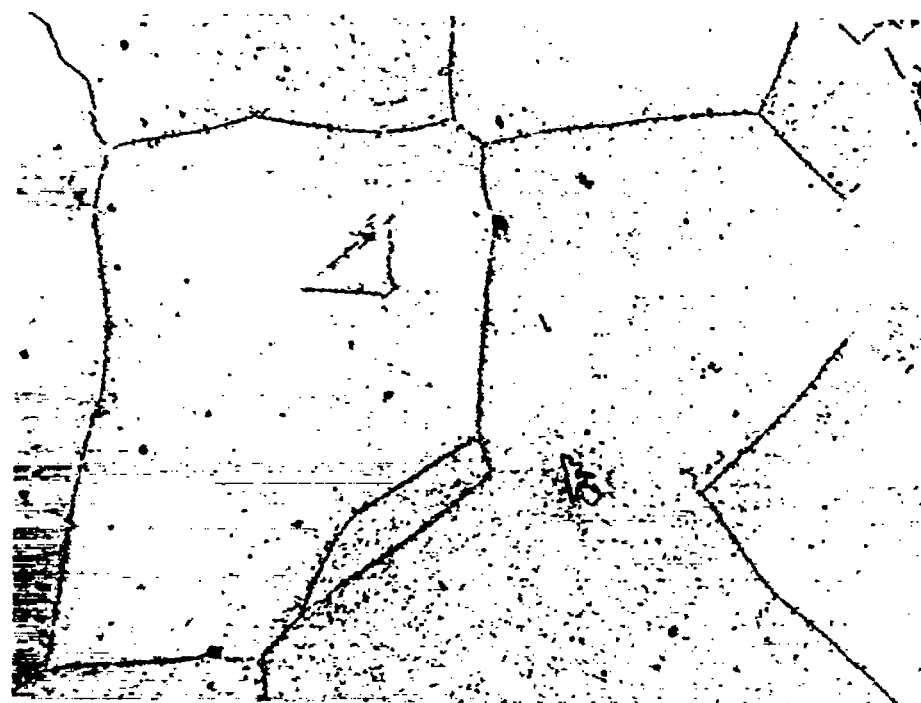
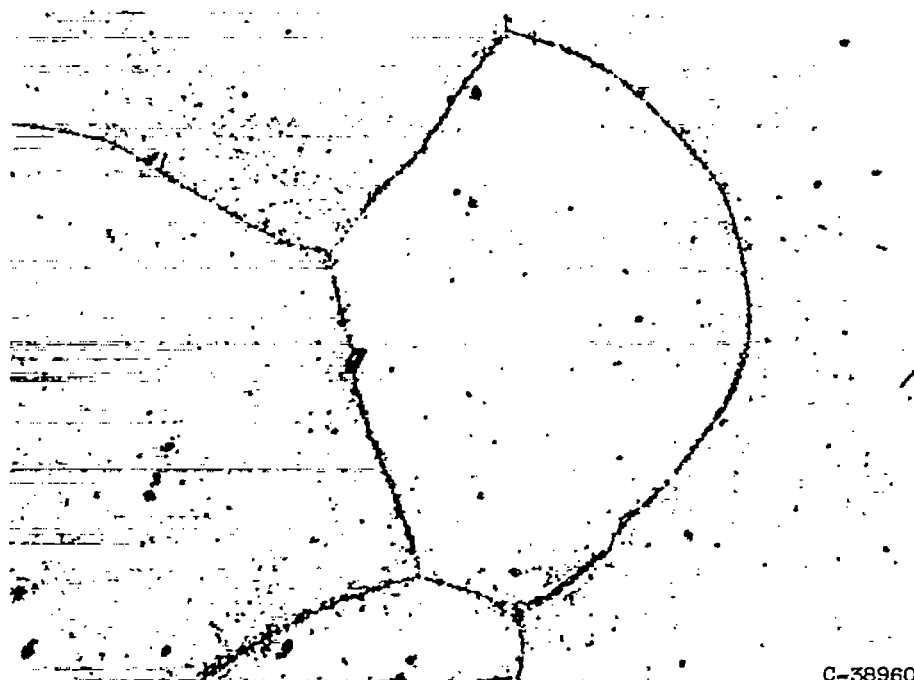
Figure 6. - Typical microstructures of heat-treated Inconel 550. Etchant: 5 cc HF, 20 cc glycerine, 20 cc water; electrolytic. (Specimen taken from group 6 blade.) X750.

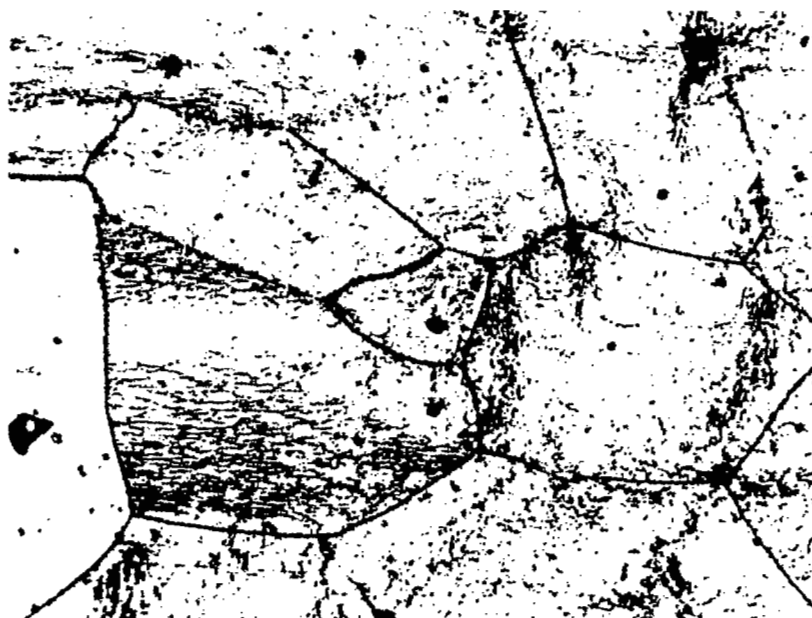
(a) Lamellar precipitate present in leading and trailing edges of blades that may have been cold-worked during forging. (Specimen taken from group 3 blade.)

Figure 7. - Microstructures frequently observed in as-heat-treated Inconel 550 blades. Etchant: 5 cc HF, 20 cc glycerine, 20 cc water; electrolytic. X750.

In precipitation-hardening alloys, the amount of precipitate within the matrix of the alloy usually depends upon the heat treatment. However, in the blades of Inconel 550, the quantity of general precipitation (visible after etching) appeared to be the same for all heat treatments used in this investigation. Furthermore, the variations in matrix precipitation were as great from section to section within single blades as variations from one group of blades to another. The microstructure shown in figure 6 may be considered typical of the majority of blades. Other types of microstructure can be seen in figure 7. Figure 7(a) shows a lamellar precipitate, which occurred in the leading and trailing edges of a few blades of each group.

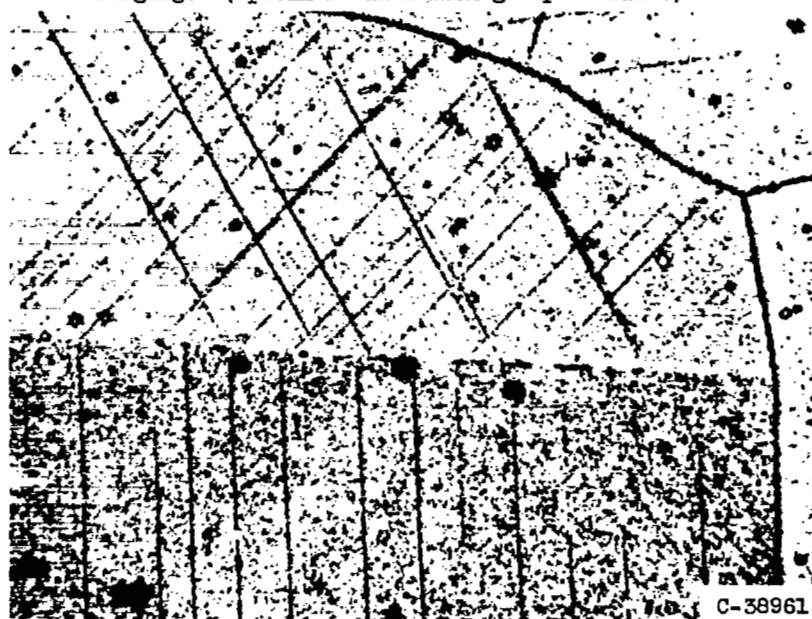
(b) Precipitate in slip planes of grains in areas that may have been cold-worked during forging. (Specimen taken from group 1 blade.)

Also, at the leading and trailing edges of blades from all groups, various degrees of slip-plane precipitation were noted (fig. 7(b)). These precipitations at the blade edges indicate that cold-working occurred during forging.

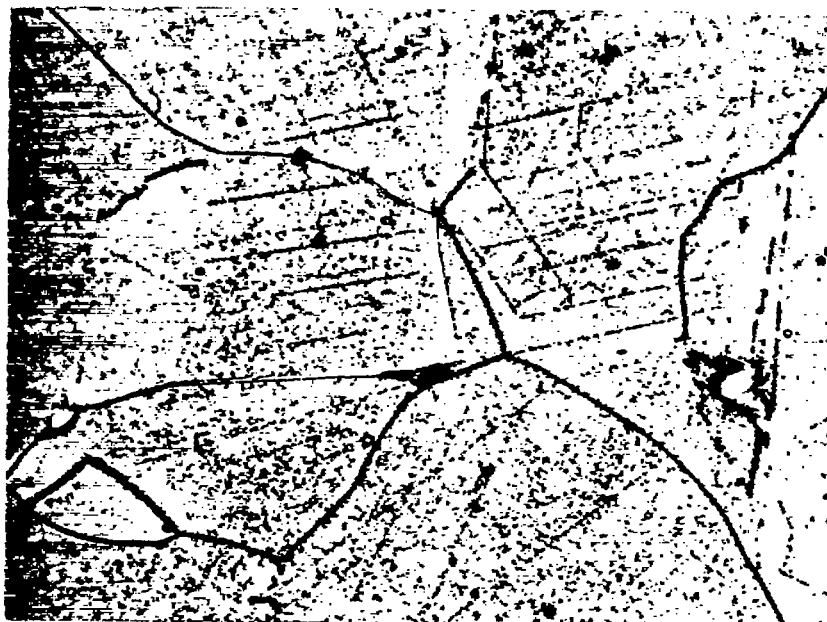
(c) Depletion zone occurring along grain boundaries away from surface of blade. (Specimen taken from group 1 blade.)

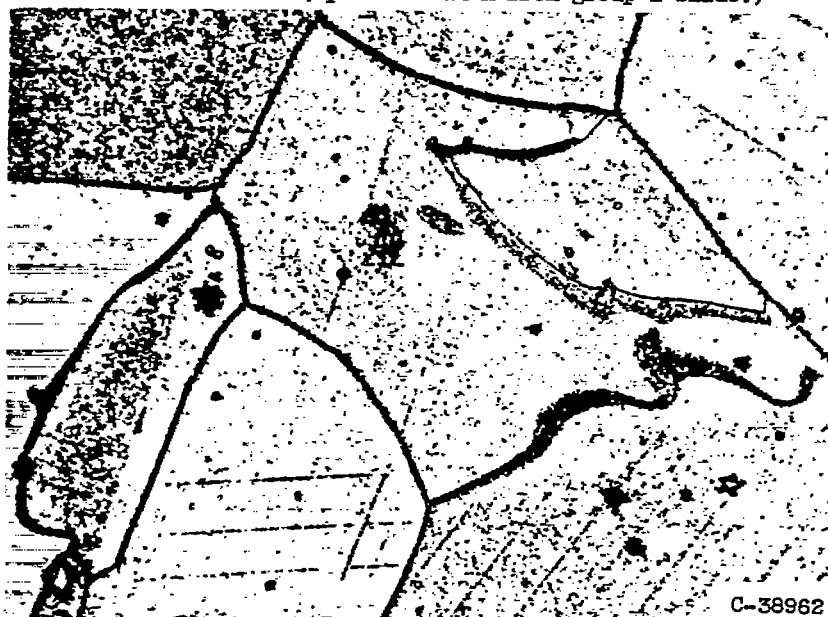
Figure 7. - Continued. Microstructures frequently observed in as-heat-treated Inconel 550 blades. Etchant: 5 cc HF, 20 cc glycerine, 20 cc water; electrolytic. X750.

The photomicrograph of figure 7(d) shows an example of a thick segregation of precipitates in a grain boundary. The greatest quantity of this type of grain-boundary precipitate that was noted in the different groups of alloys is shown in figure 7(e).

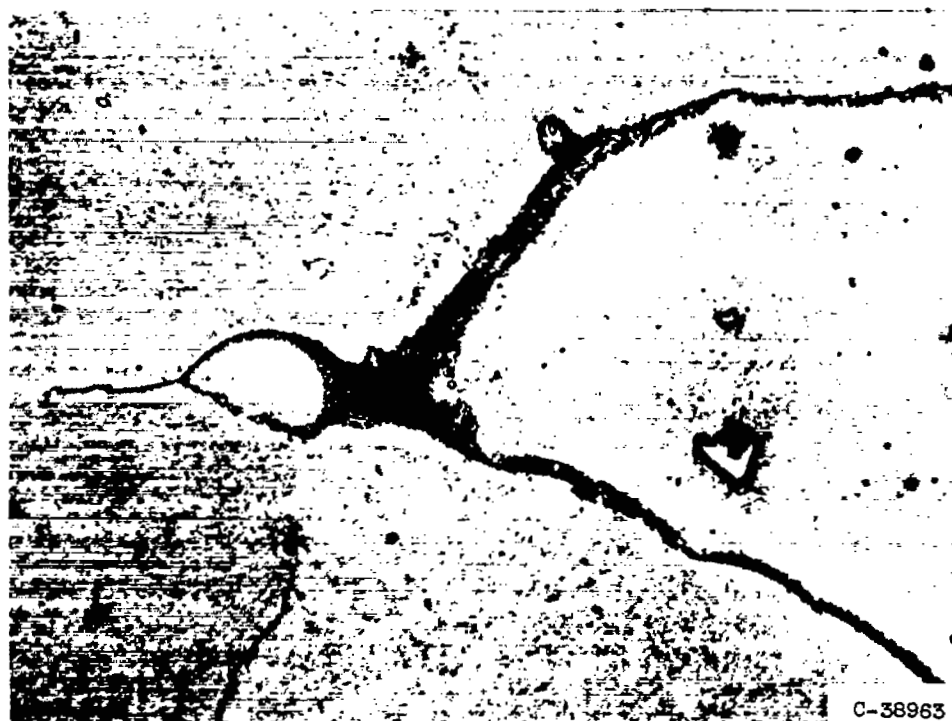
(e) Greatest quantity of grain-boundary precipitate noted.
(Specimen taken from group 1 blade.)

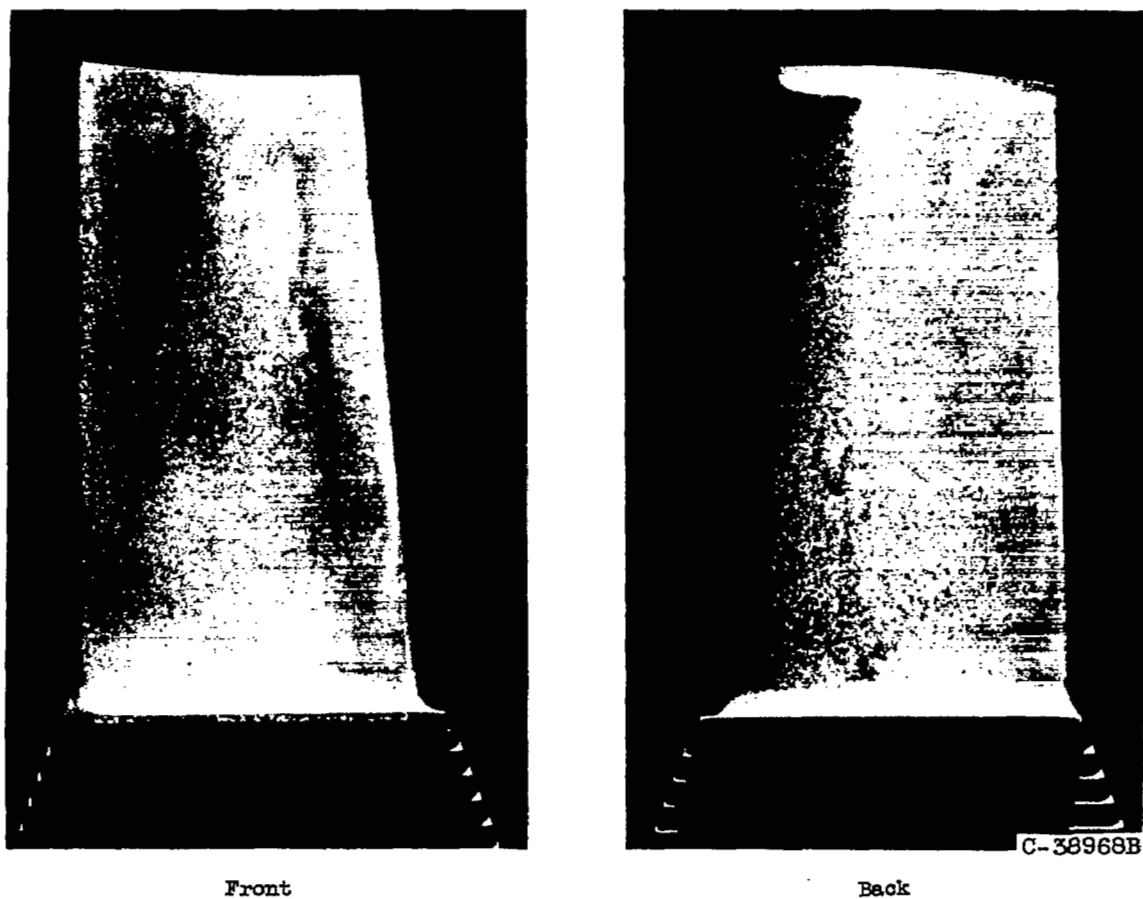
(h) Group 5 blade, smallest grains noted.

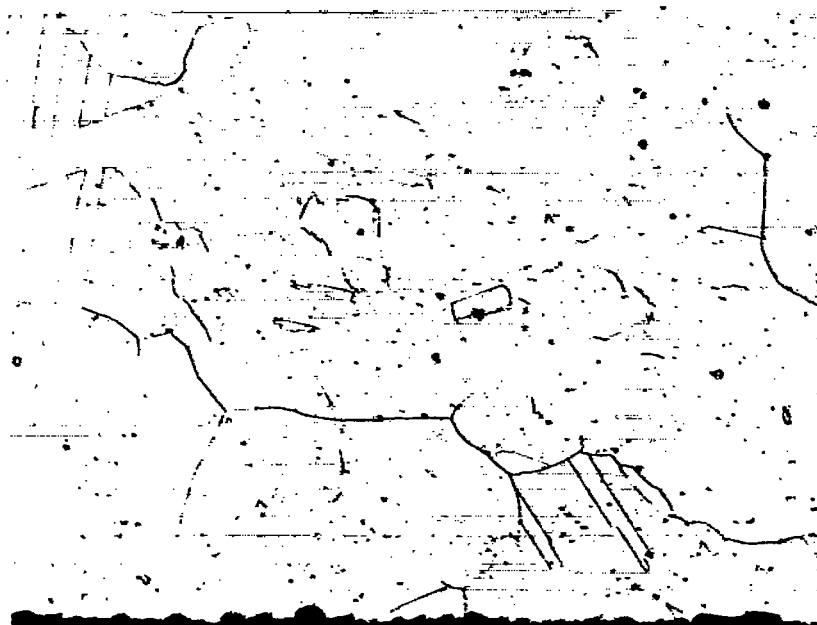
(a) Large grains occurring in trailing edge of group 1 blade. X100.

Figure 9. - Micrograin size of as-heat-treated Inconel 550 in cross-sectional specimens taken $2\frac{3}{16}$ inches above base platform of blades. Etchant: 5 cc HF, 20 cc glycerine, 20 cc water; electrolytic.

Grain-size measurements made on cross sections $2\frac{13}{16}$ inches from the blade base are shown in table IV and figure 9. Both coarse and very fine grains were observed in almost all the specimens. These sections are not necessarily representative of the grain sizes of the entire airfoil. Therefore, the macroetched blades are considered to give a better indication of relative grain sizes.

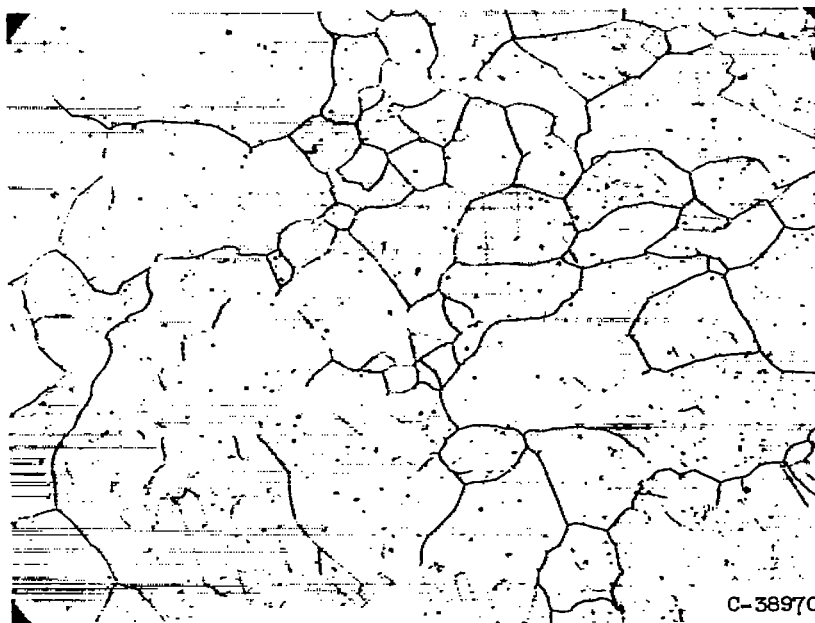
(b) Mixed grain size in cold-worked area of trailing edge of group 1 blade. X50.

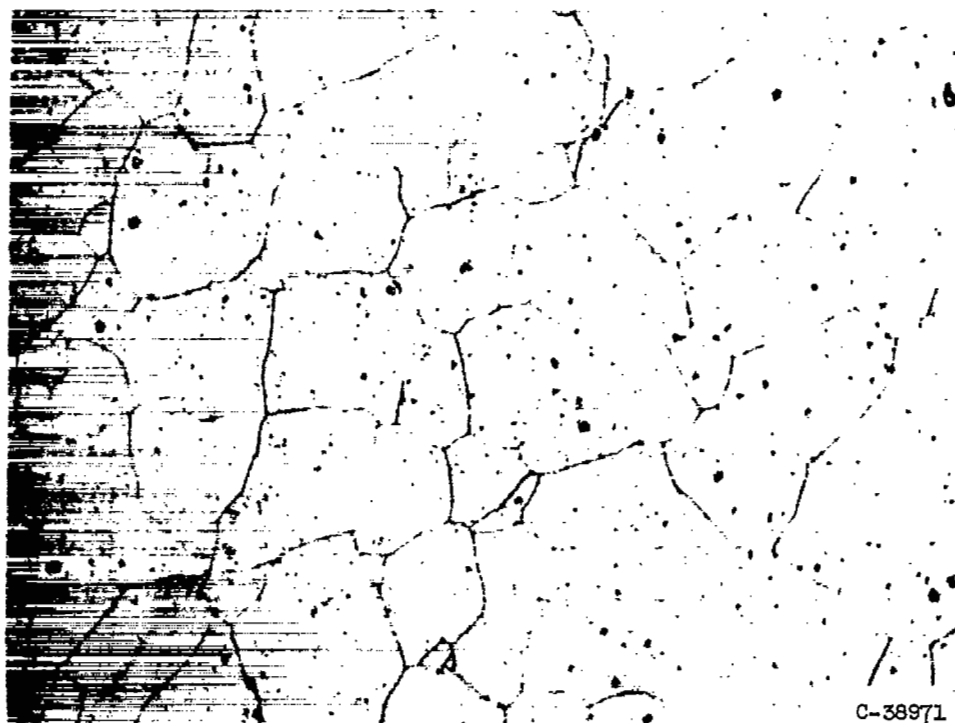
(c) Typical grain size in cross section of group 2 blade. X100.

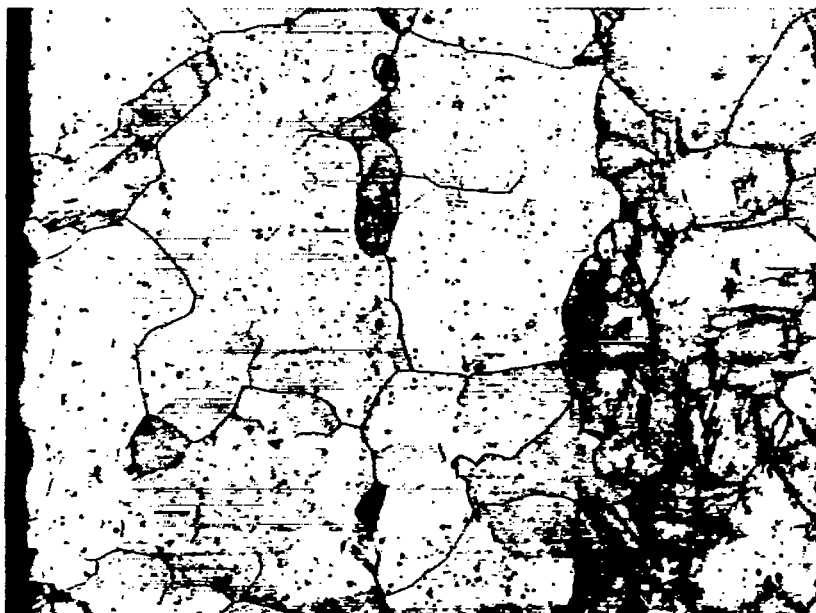
(d) Grain growth in surface cold-worked area of group 3 blade. X100.

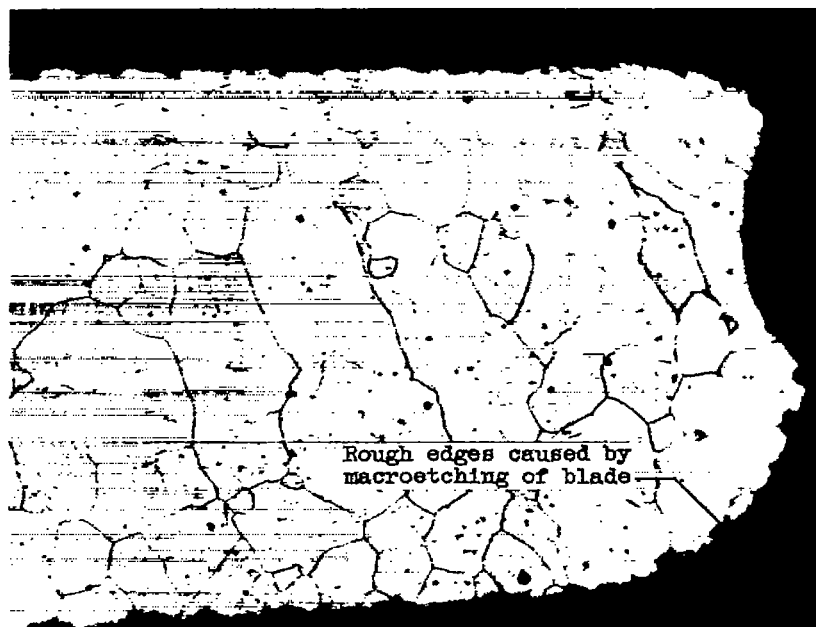
(f) Mixed grain sizes occurring in trailing edge of group 4—blade. X100.

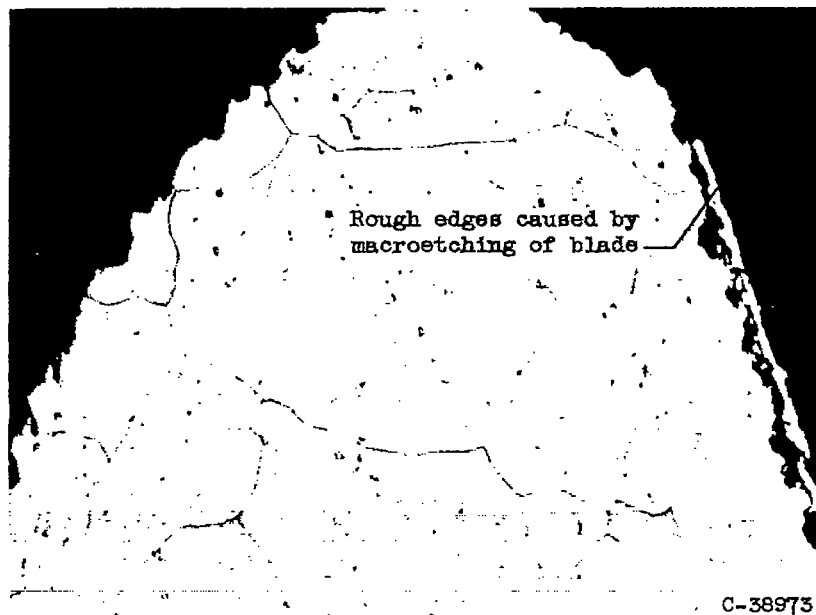
(g) Large grains in leading edge of group 4 blade. X100.

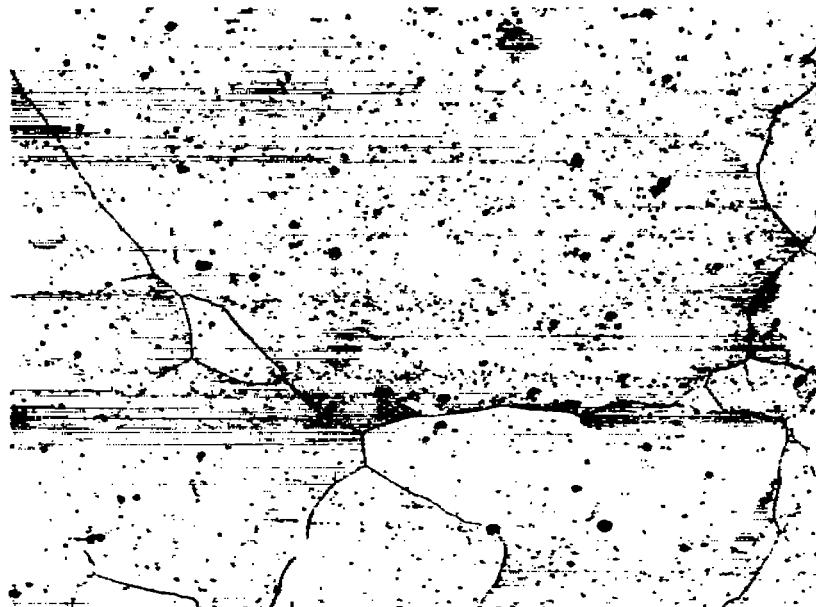
(h) Large grain in trailing edge of group 5 blade. X100.

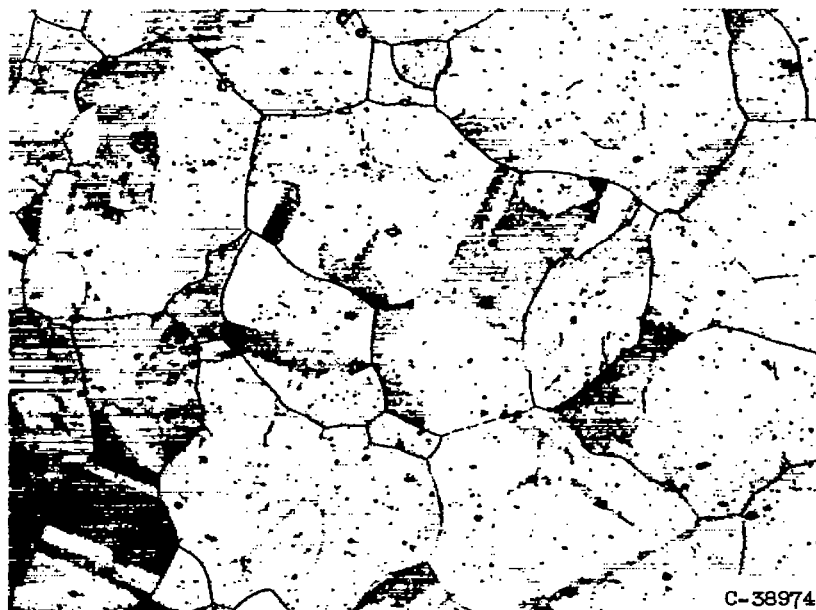
(i) Average grain size of group 5 blade. X100.

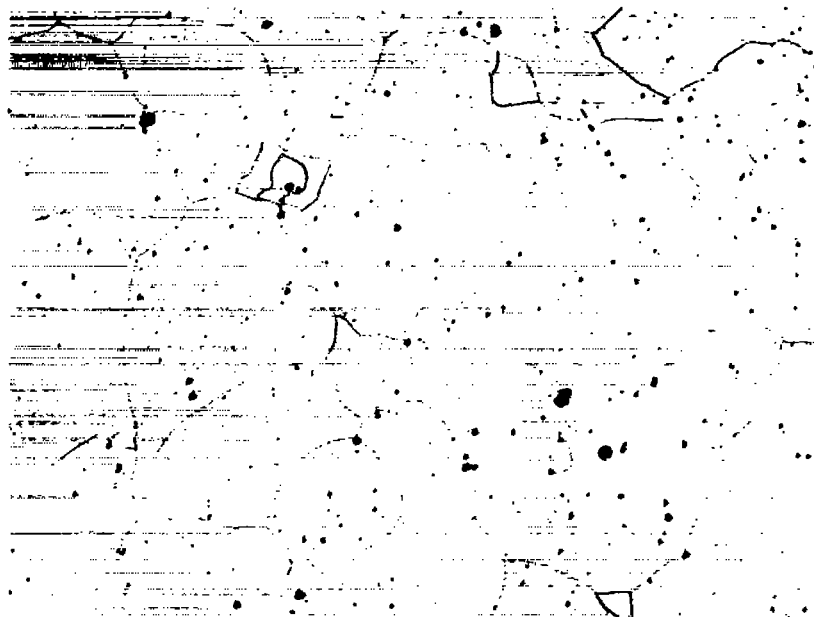
(j) Average grain size in group 6 blades. X100.

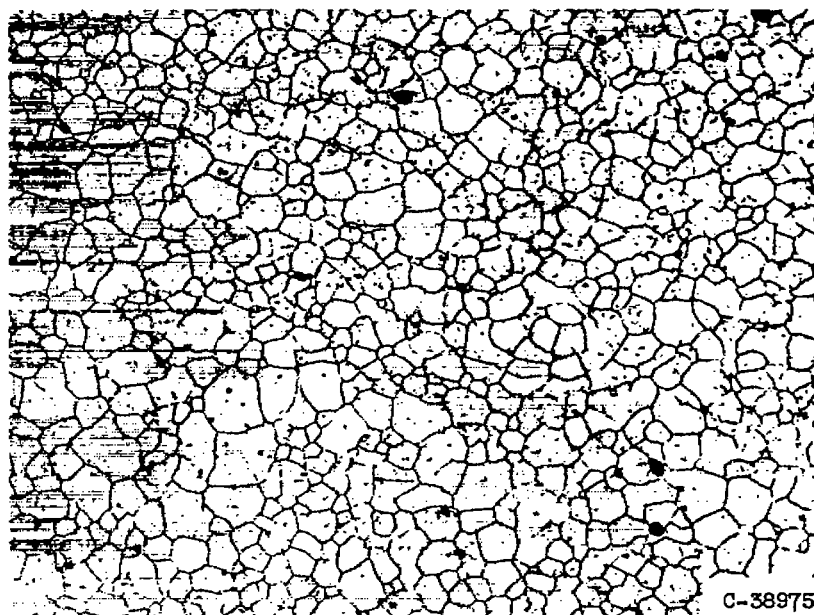
(k) Finest grain size occurring in Inconel 550 blades.
(Specimen taken from group 6 blade.) X100.

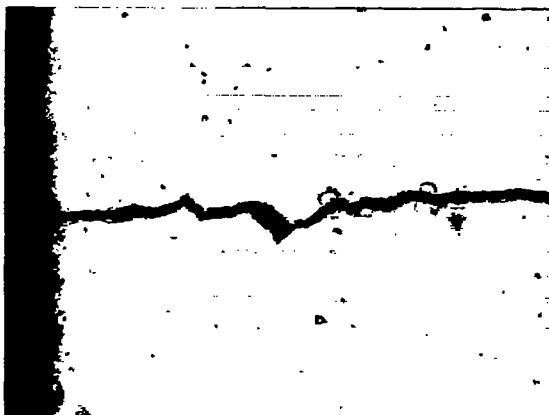
First failure - Fatigue failure in leading edge of airfoil 3.25 inches above base platform after 450 hours at rated speed. Note depletion zone and oxide penetrations along leading edge. X100.

Photomicrographs of failure origins of first and last blade failures for each group are shown in figure 10. No definite microstructural differences were noted between first and last failures even though the difference in life was as great as 469 hours. The only definite difference between the microstructures of heat-treated and operated blades was that the operated blades etched more rapidly. All specimens examined had depletion zones and showed some oxide penetration of the grain

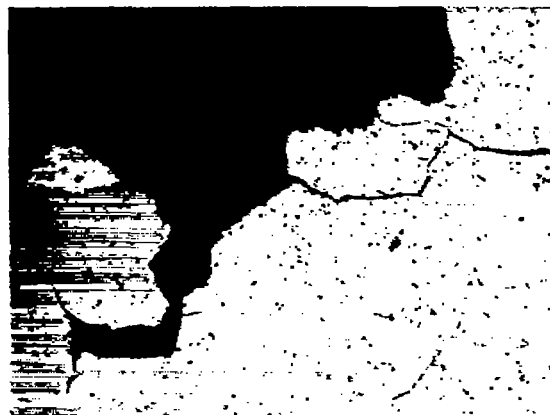
Third last failure - Stress-rupture failure after 848 hours at rated speed $2 \frac{3}{16}$ inches above base and $\frac{5}{8}$ inch in from leading edge.

Note intergranular nature of failure. (Last two blades failed by fatigue at 857.5 hours at rated speed.) X100.

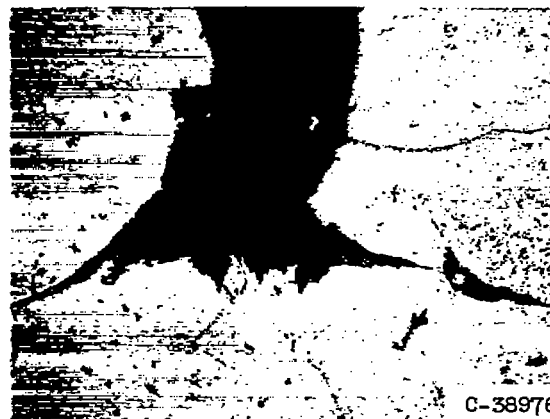
Section of failure-origin area showing intergranular nature of failure propagation. X750.

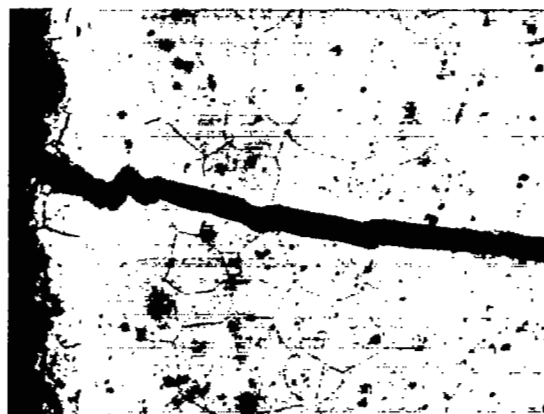
Last failure - Fatigue failure occurring in leading edge $3\frac{3}{32}$ inches above base platform after 788 hours at rated speed. Note depth of depletion zone and excessive oxide generation of trailing edge. X100.

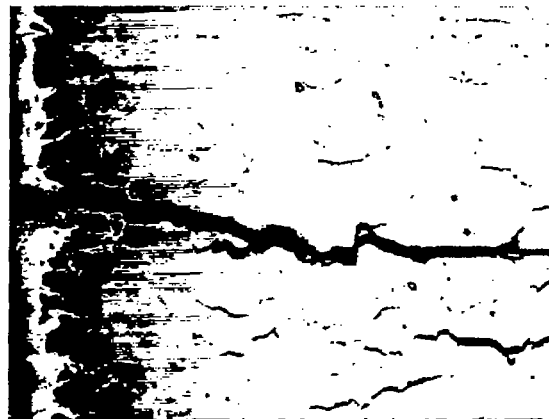
Last failure - Failure occurring by stress-rupture plus fatigue in leading edge $3\frac{1}{32}$ inches above base platform after 540 hours at rated speed. Note recrystallization in depletion zone, oxide penetrations and stress-rupture tearing present in failure area. X100.

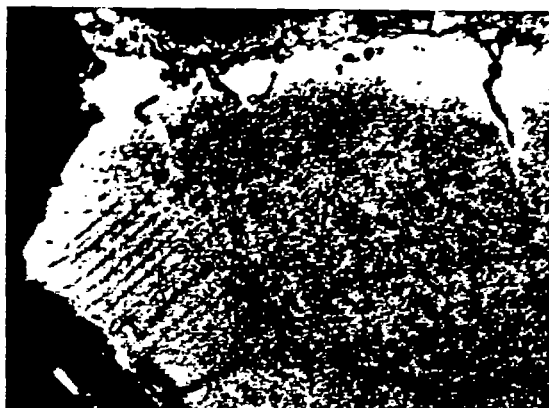
Failure origin of above specimen at X750. Note oxide penetration of grain boundary and presence of recrystallized grains in depletion zone.

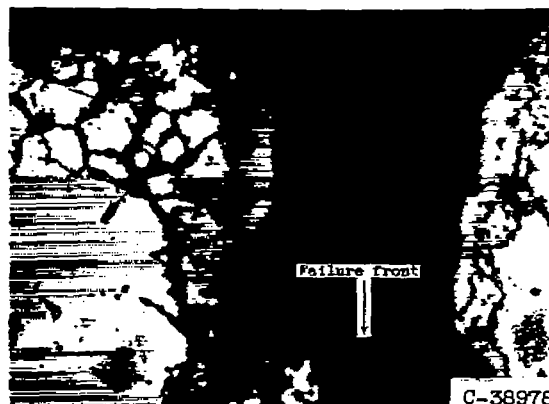
(c) Group 3.

Failure origin of above specimen at X750.

Figure 10. - Continued. Microstructures of failure origins of first and last failed Inconel 550 blades operated in engine under cyclic operating conditions. Etchant: 5 cc HF, 20 cc glycerine, 20 cc water; electrolytic.

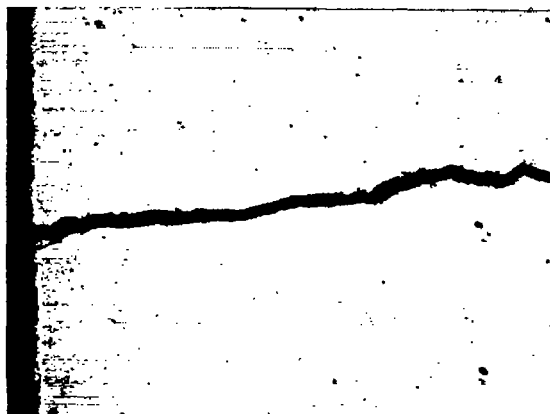
First failure - Fatigue failure originating in leading edge 3 inches above base platform after 290 hours at rated speed. X100.

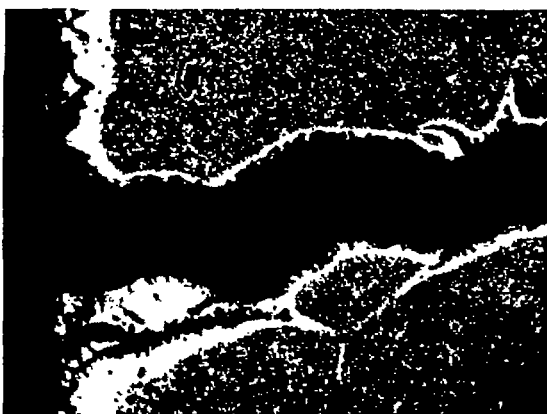
Failure origin of above specimen at X750. Note oxide penetrations and extent of depletion of leading edge and grain boundaries adjacent to failure path.

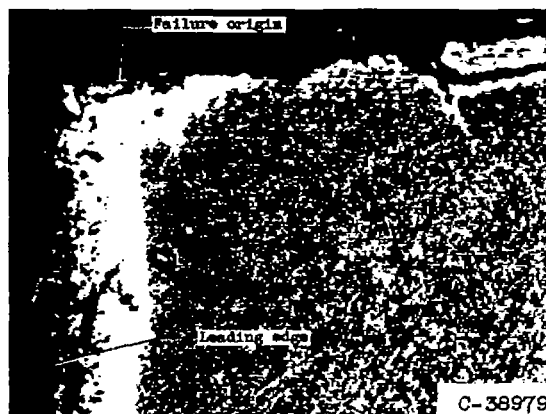
Failure origin of above specimen at X750. Note depletion zone in grain boundary in interior of specimen.

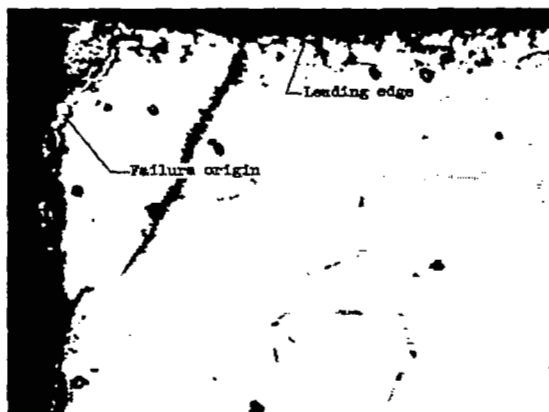
Failure origin of above specimen at X750. Note recrystallization in depletion zone and extent of oxide penetration.

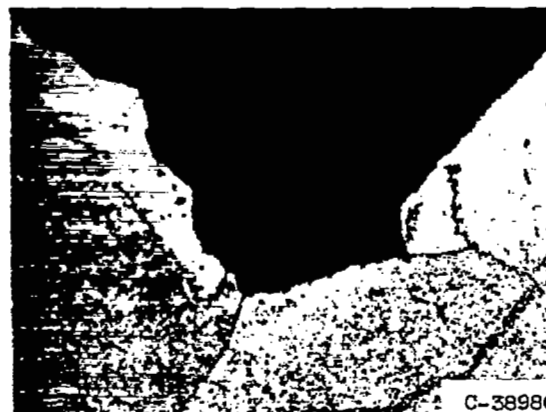
Section of above failure edge at X750 indicating intergranular nature of failure.

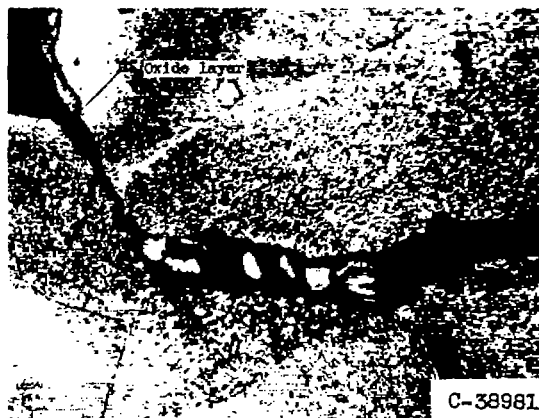
Section of above failure edge at X750. Note oxide layer present on failure edge and intergranular nature of failure.

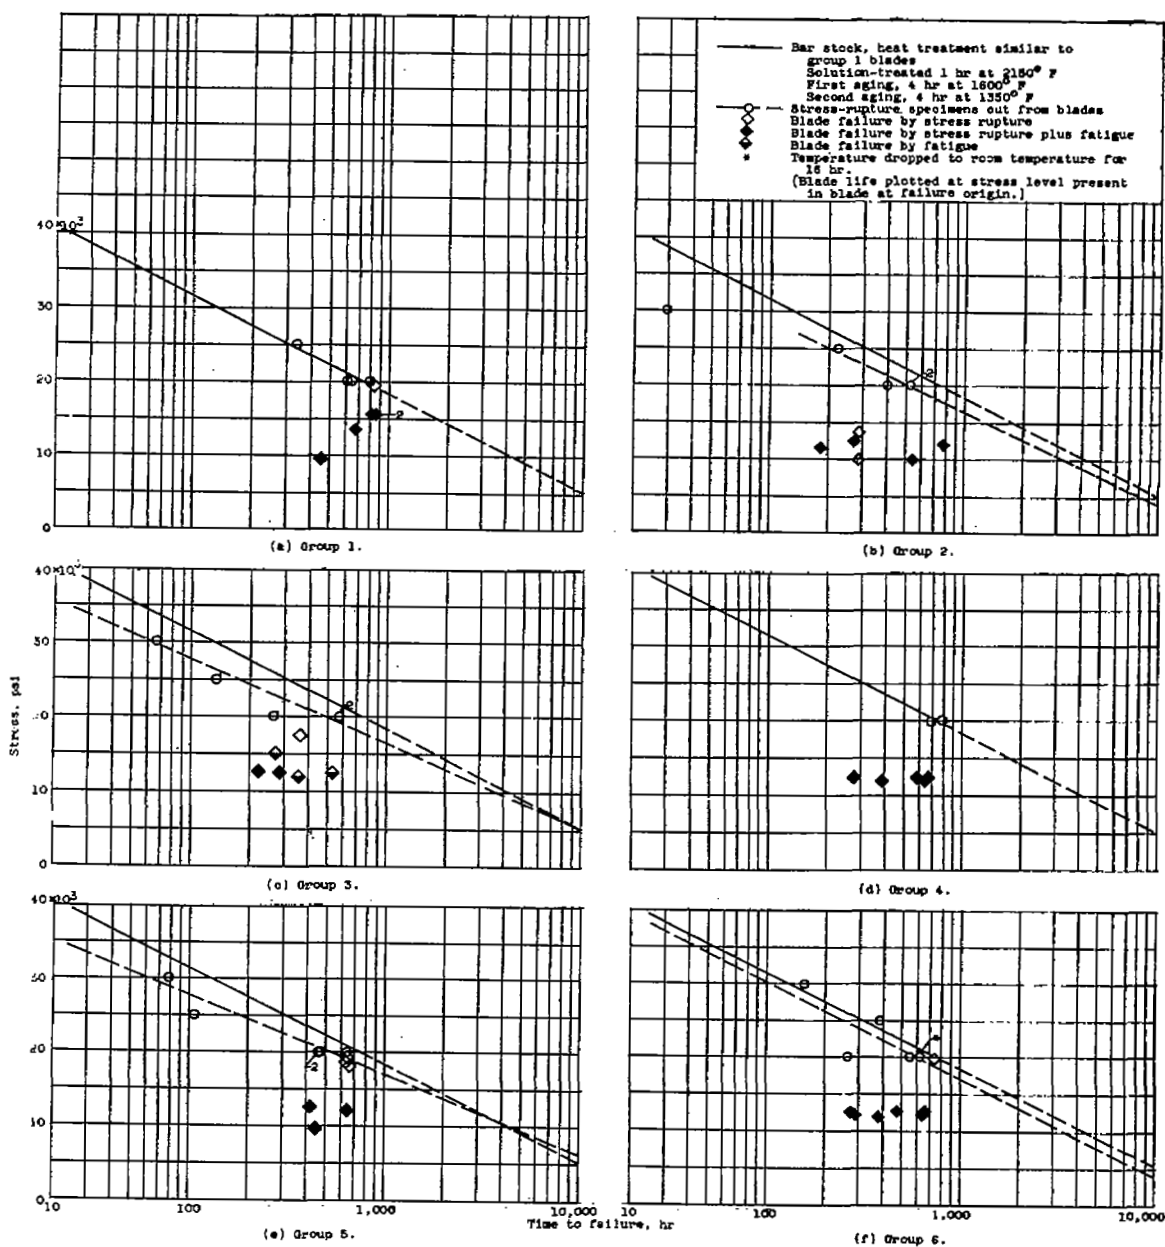
Figure 12. - Comparison of blade life and stress-rupture life of bar stock and specimens cut from blades at 1500° F test temperature.

The stress-rupture lives of specimens cut from blade airfoils are given in table II. These values are also plotted in figure 12 along with the stress-rupture strength of bar stock given the same heat treatment as group 1. Blade-life values of the different groups are also plotted in figure 12 at stress levels corresponding to the centrifugal stresses at the failure origins in the blade airfoils. Reasons for plotting in this manner will be discussed later.
